LATAM B787-9 AIRCRAFT CABIN PHOTO-RECON & METROLOGY INSPECTION PREFLIGHT & POST-FLIGHT MADRID->FRANKFURT AUG 01, 2018

(updated: 05 Sep 2018)

Glenn Schneider and John Beattie (TSE 2019/EFLIGHT 2019-MAX)

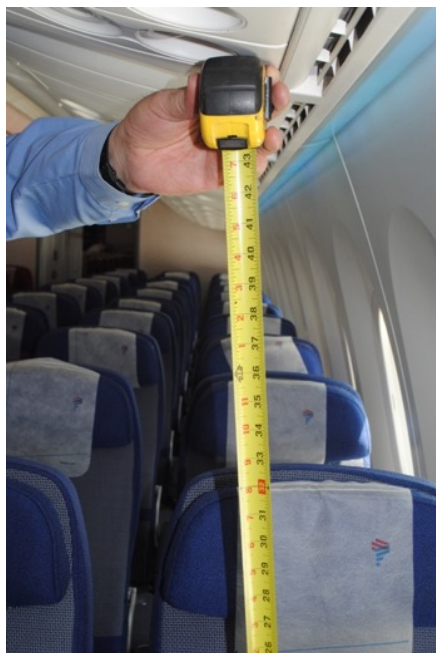
The main cabin seat backs are 33 inches tall measured from the top of the seat cushion. The low point of the bottom of the overhead carryon storage bins are 46 inches above the floor.

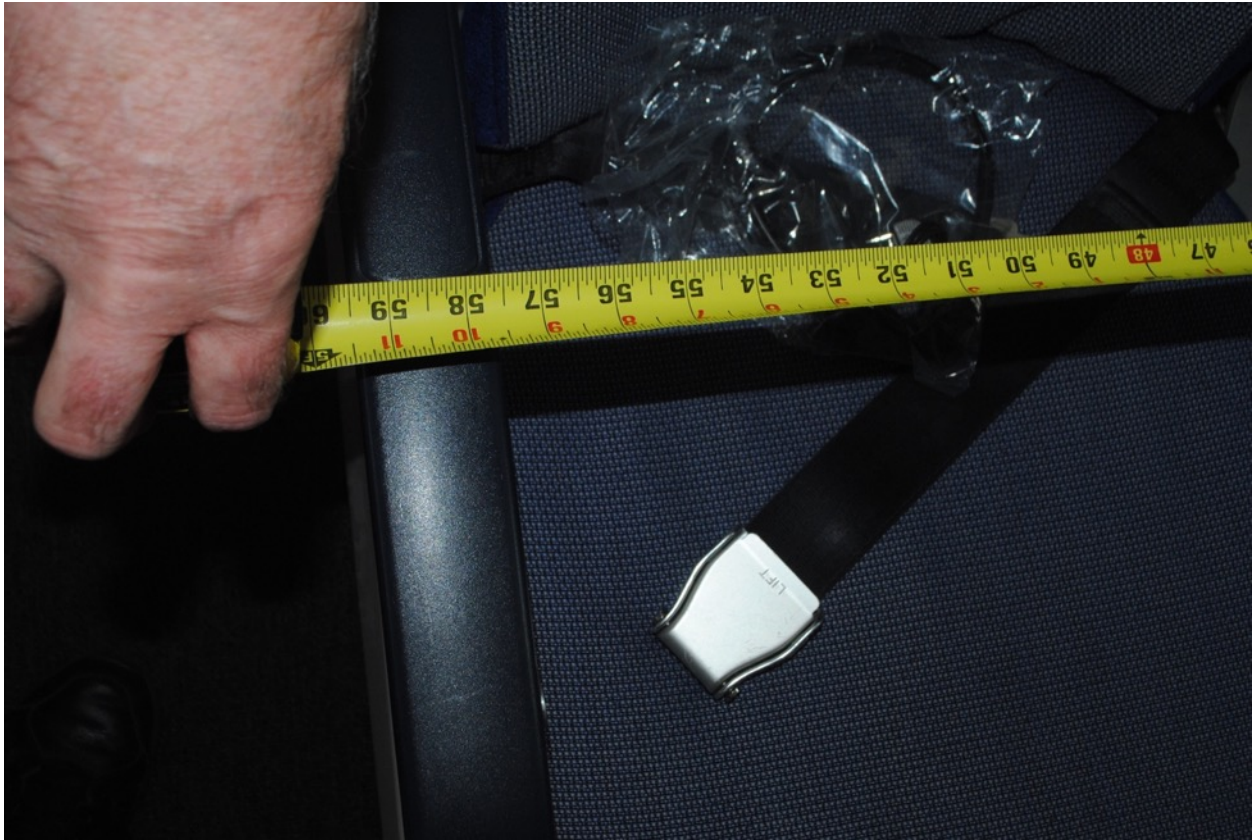
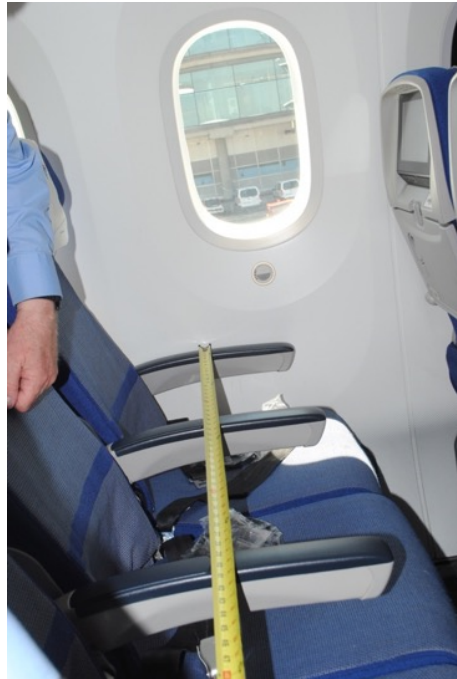
The seat-row bench (3-side-by-side except row 43 which is 2-side-by-side) is 59-1/4" in length from the outside of the non-retractable arm rest on the left side of seat A to the non-retractable arm rest on the left side of seat C. There is a 1-1/4" to 1-3/4" gap between the left (seat A) side arm rest and the fuselage wall.

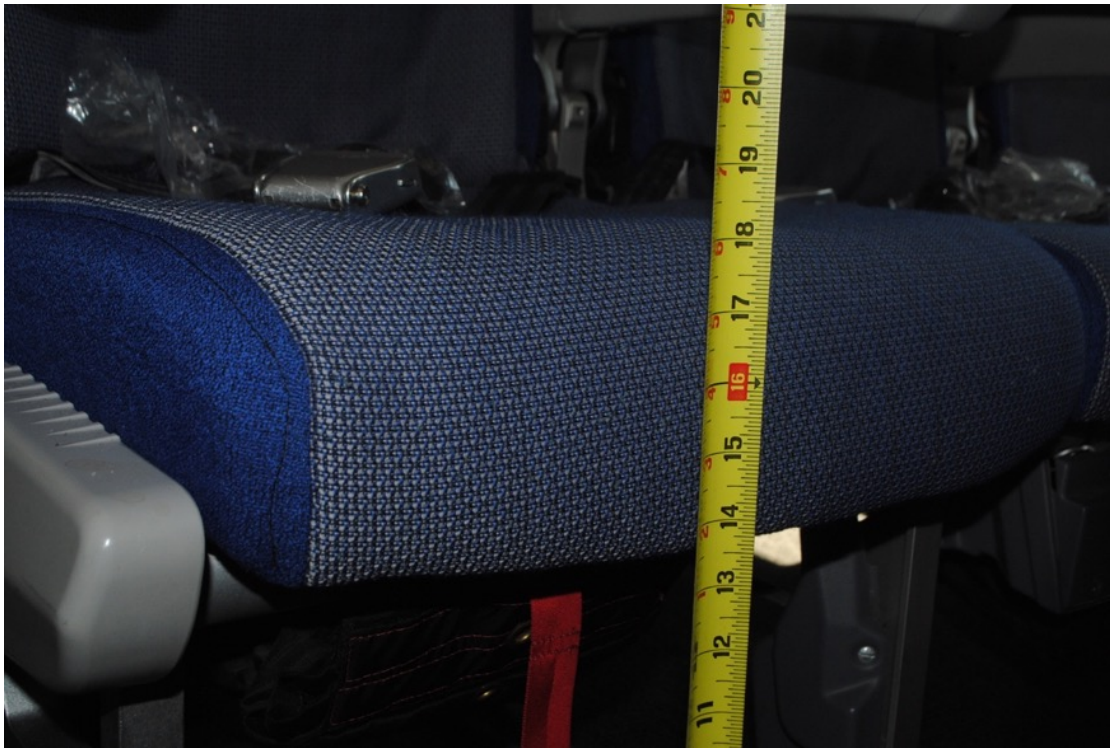
The seat cushion tops are 18" above the floor. The seat cushion bottoms are 13.5" above the floor.

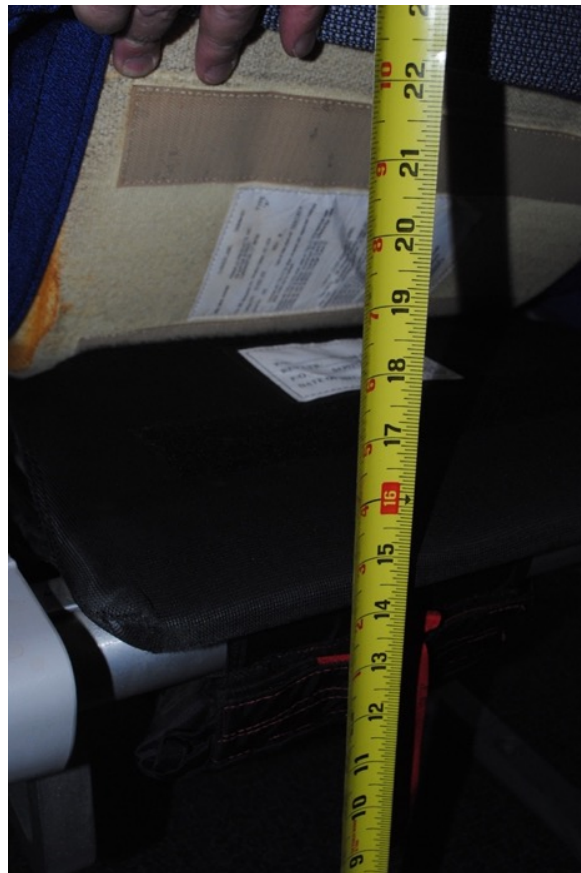
The seat cushions are easily removable and reattached – held in place only by Velcro.

The top of the seat itself (with cushion removed) is ~ 14-3/4" inches above the floor.

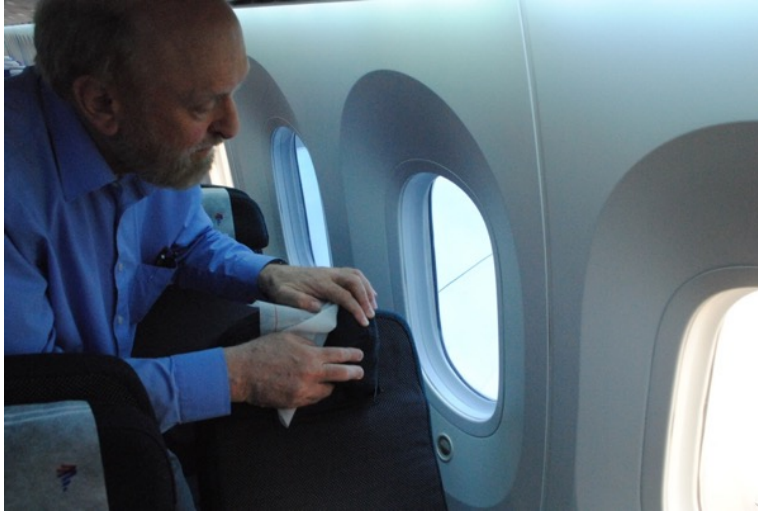
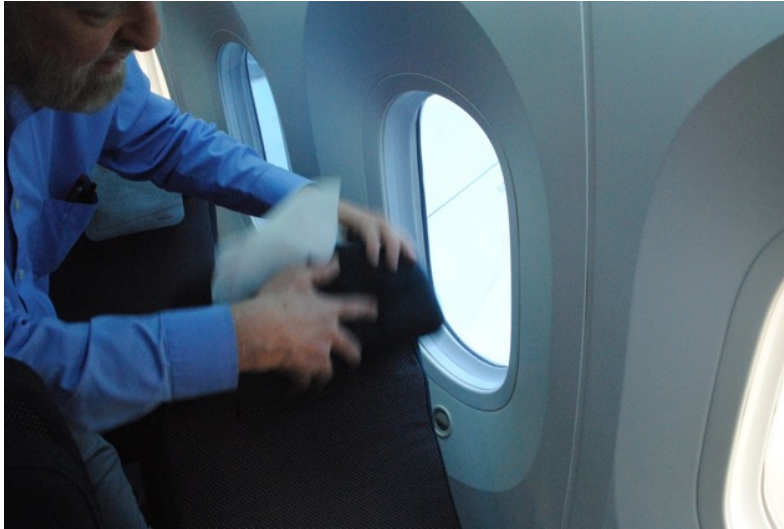
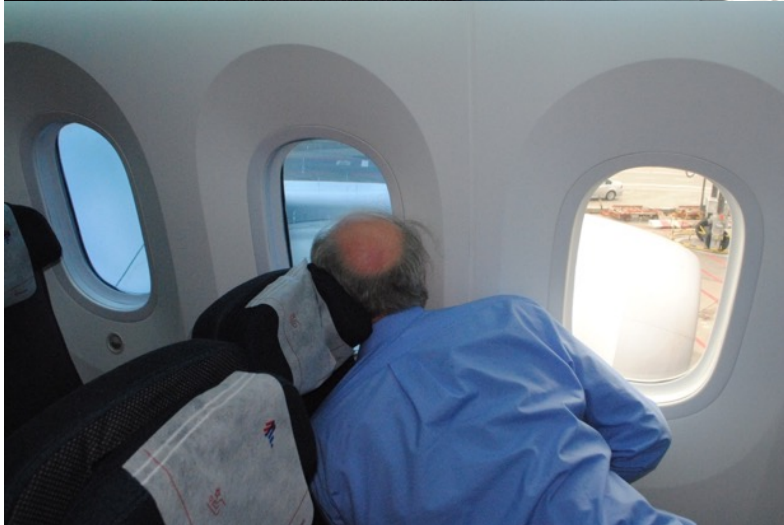
In the main cabin, the headrests can move up about 3", and also include adjustable "ear flaps" that can be bent forward to provide additional room to look "back" out the seat-adjacent windows to provide a better view of the approaching lunar shadow. This in addition to tilting a seat back if permitted in a given row per the seating chart booking information:

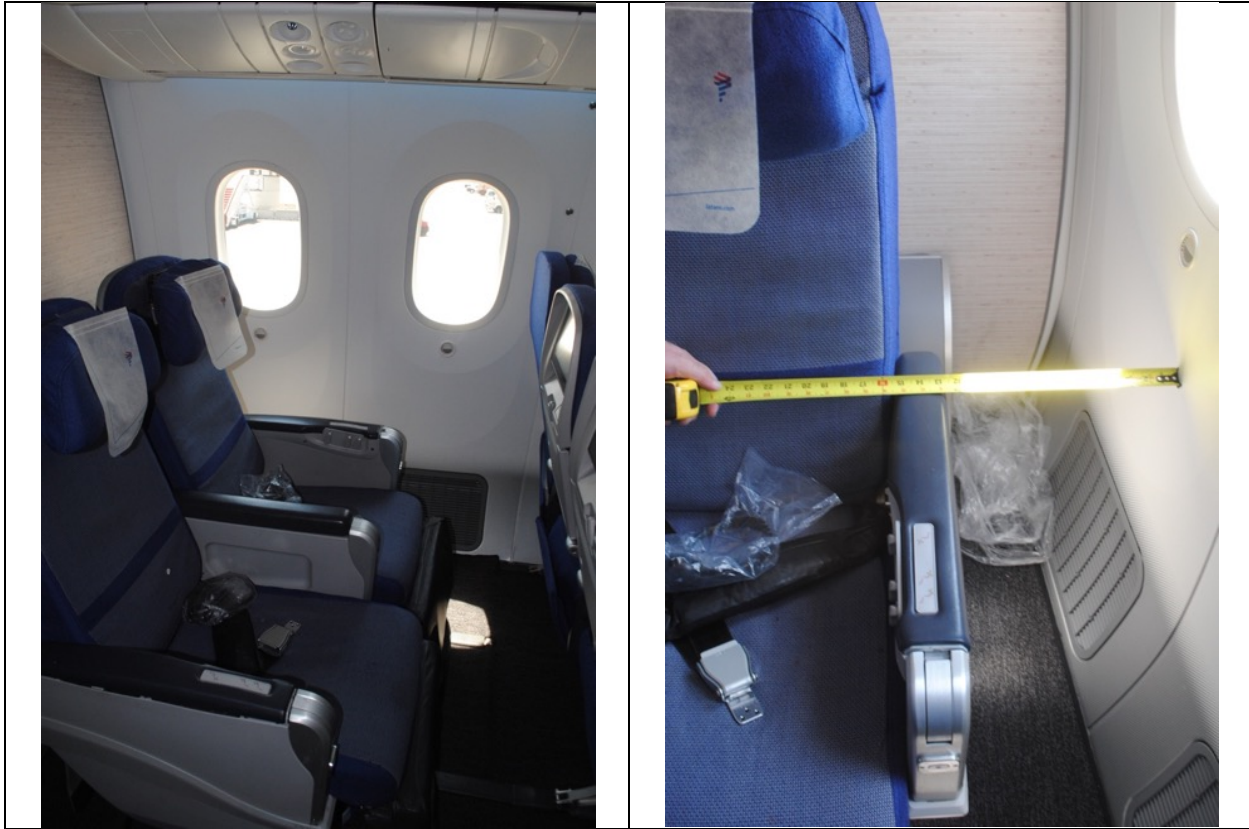
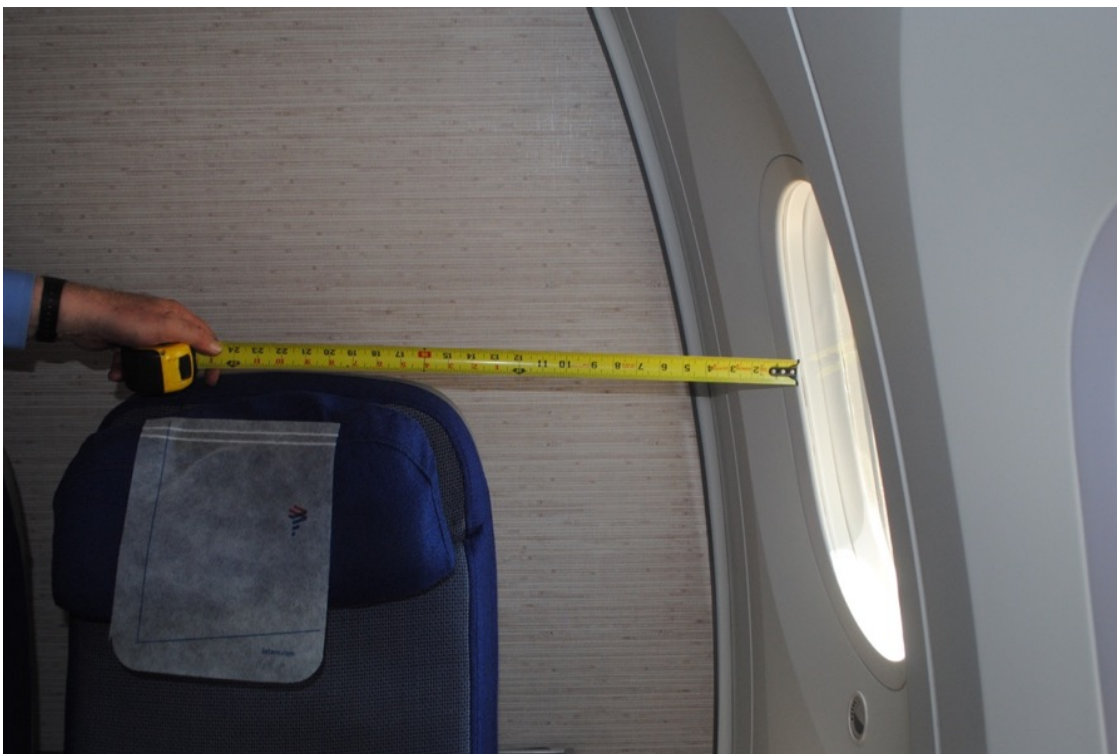
ROW 43

Row 43, which is the last row in the aircraft with the rear cabin bulkhead behind, is unique in that it has only two seats (A and B). There is an air gap of appx 13-inches between the fuselage wall and the left side of the seat-A arm rest, and larger spacing from window to seat.

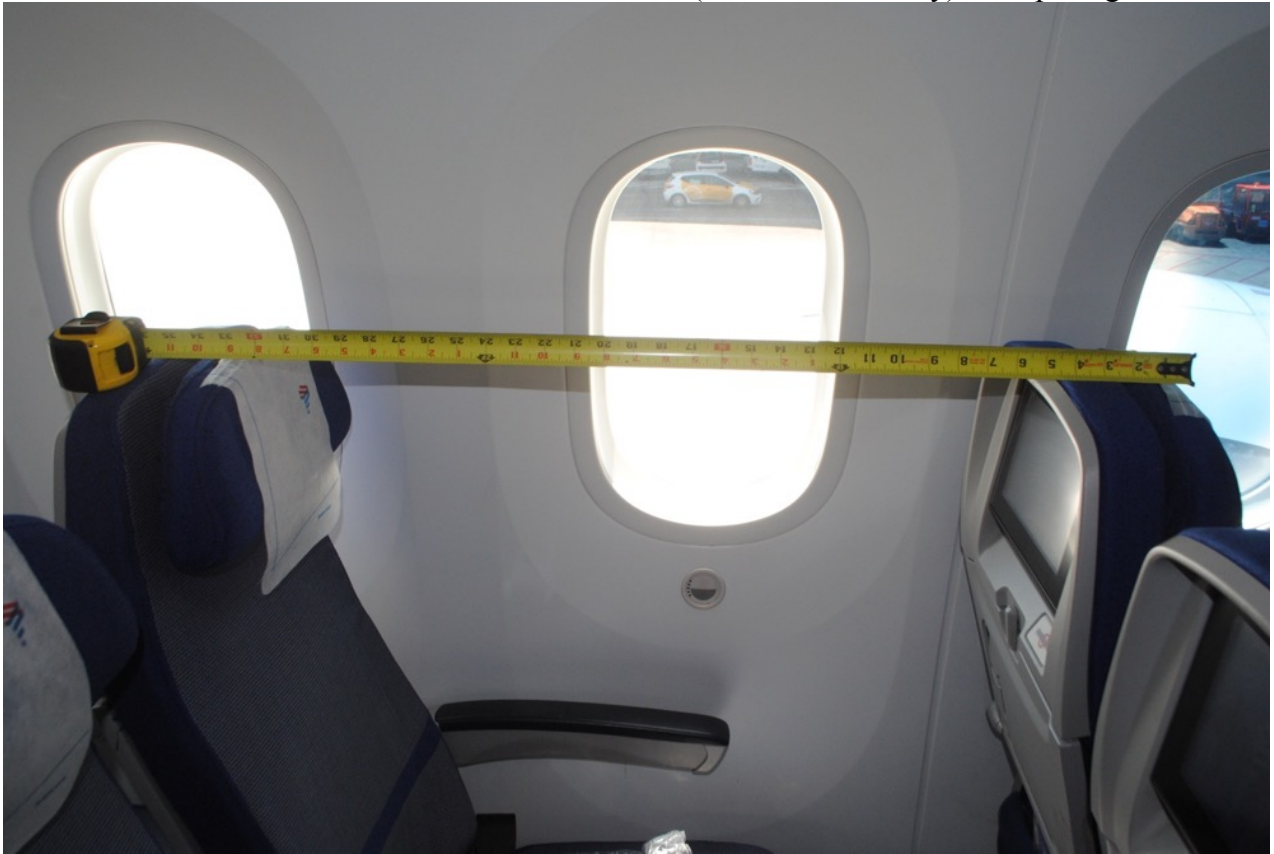
Seatback headrest cushion pillow front (19) to pillow front (18) distance 32-inches

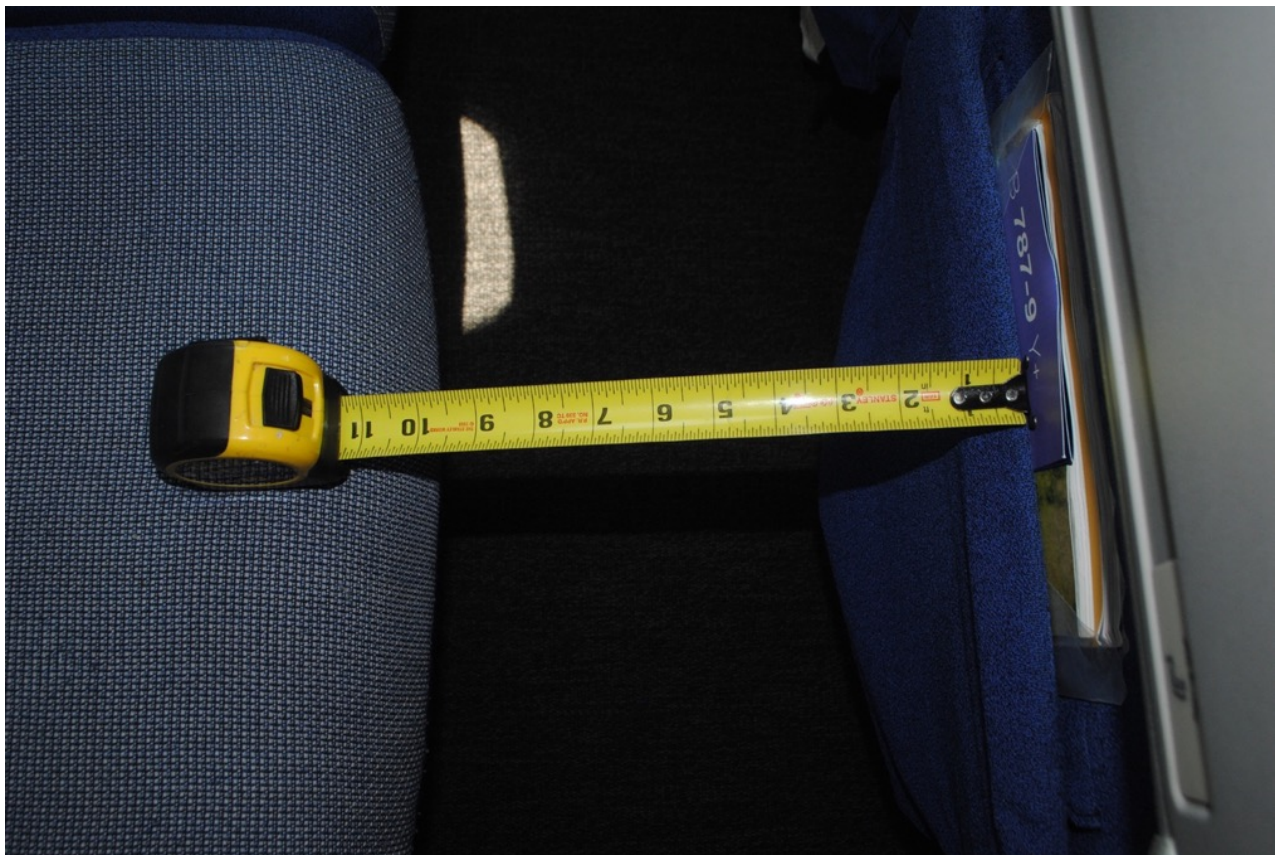
Standard economy “leg” room (seat cushion to seat-back pouch spacing)

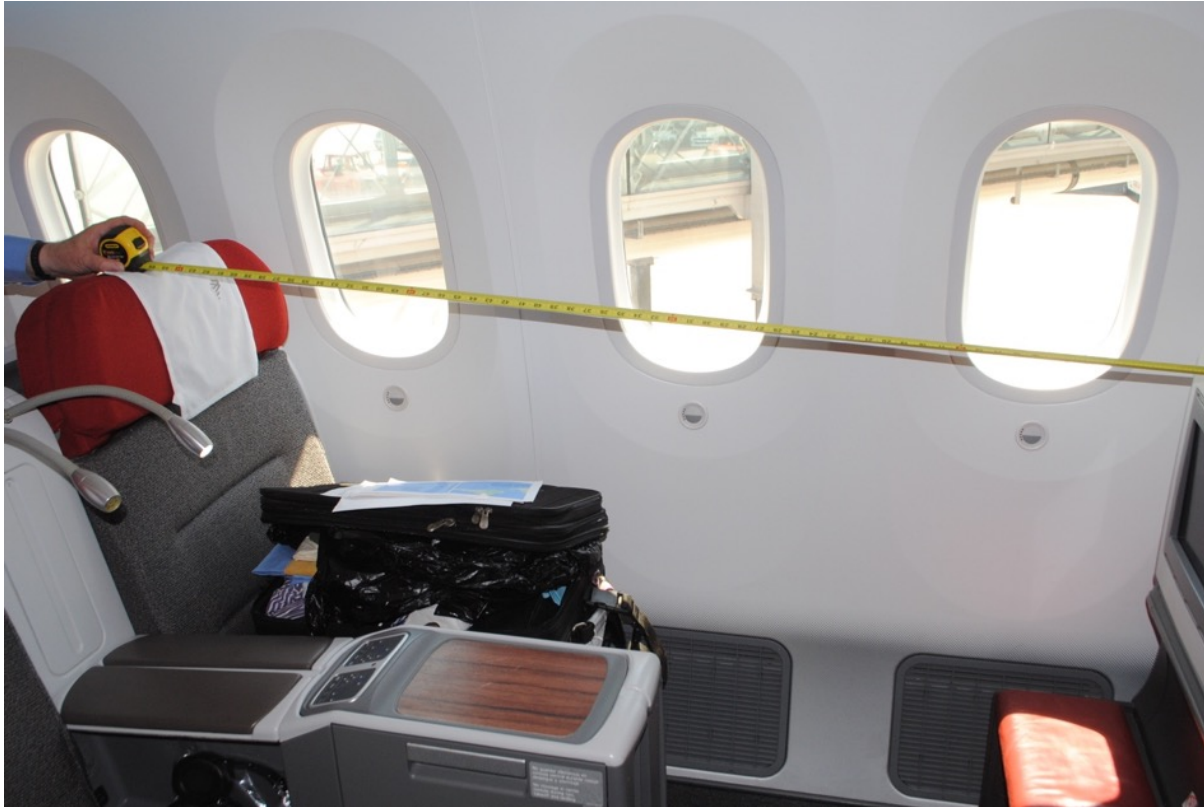
Each business class row area has two seats (A [window] and B [aisle]) and, EXCEPT for row #4, three windows. In each row, the windows are designated: Z (rearmost, next to the seat), Y (middle), X (front most). Row 4 has no “X” window. The layout of the seating and floor areas of these 4 rows are identical. Row #1 is a little different as at its forward end is the business cabin bulkhead, and its area is ~ 3-1/2” shorter than rows 2-5 as shown on page 39. Here is a view of a whole business section row area. This particular photo is actually for row #2. The tape measure shows the distance between the front of the row #2 head-rest cushion in the full upright position and the seat-back of row #1 – which is 65 inches. The full distance from seatback to seatback is 75 inches (except row 1 which is 71.5 inches).

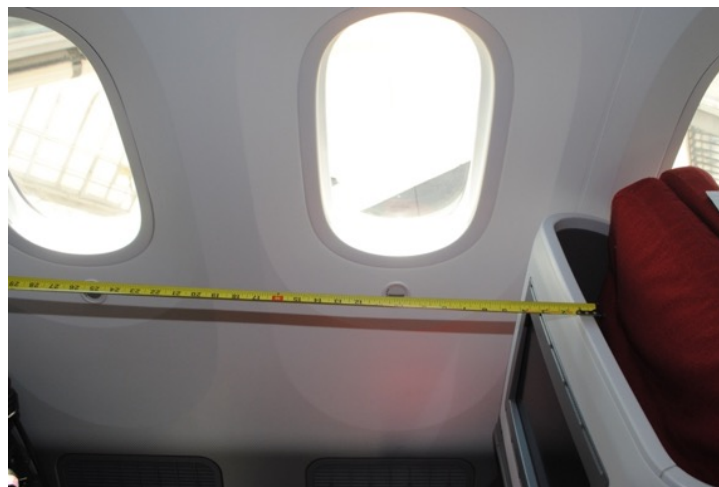
The locations of the three windows to the individual seating areas vary a bit from row to row, and will also be shown for each row. Here is a supplemental photo that shows for row #2 the specific location of its X window with respect to the Row 1 seat back...

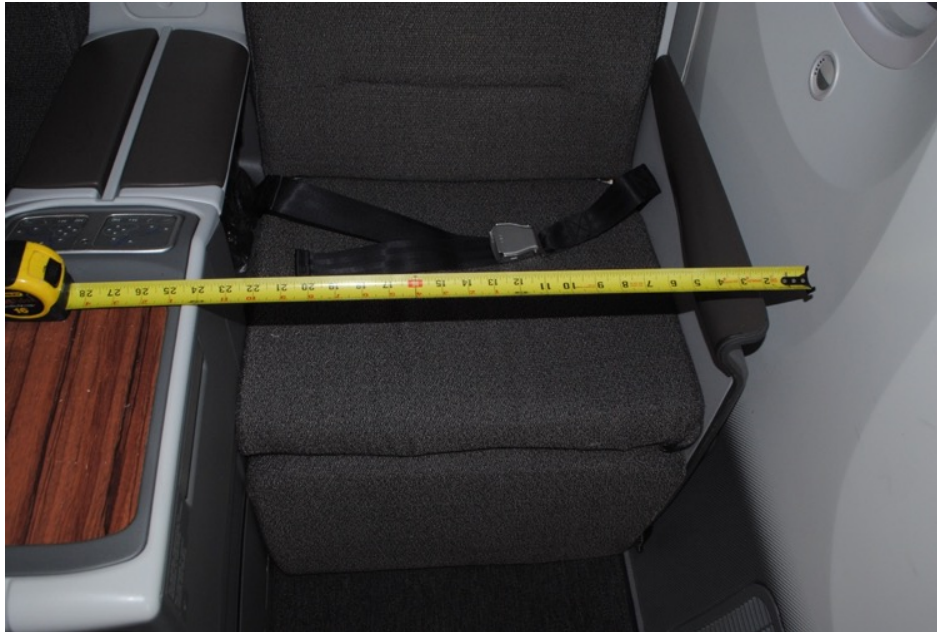
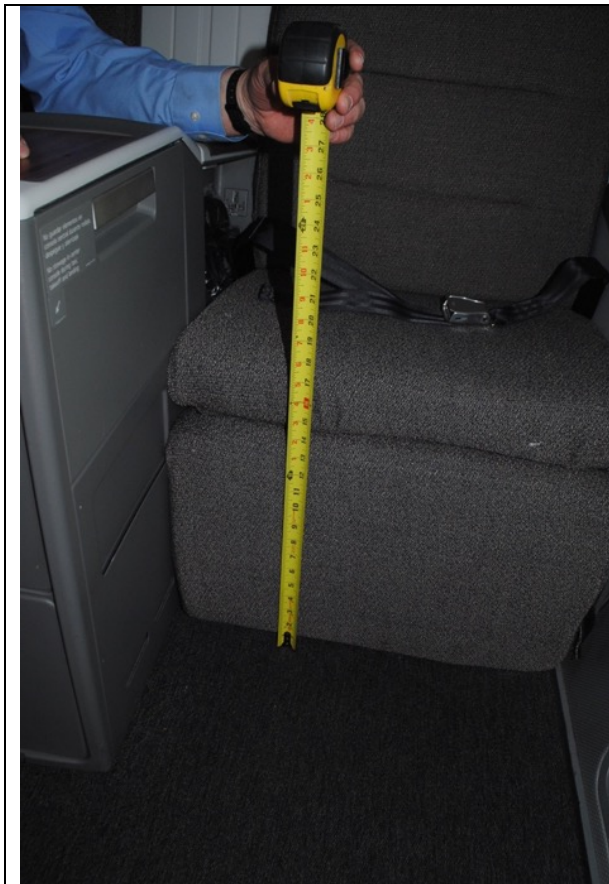
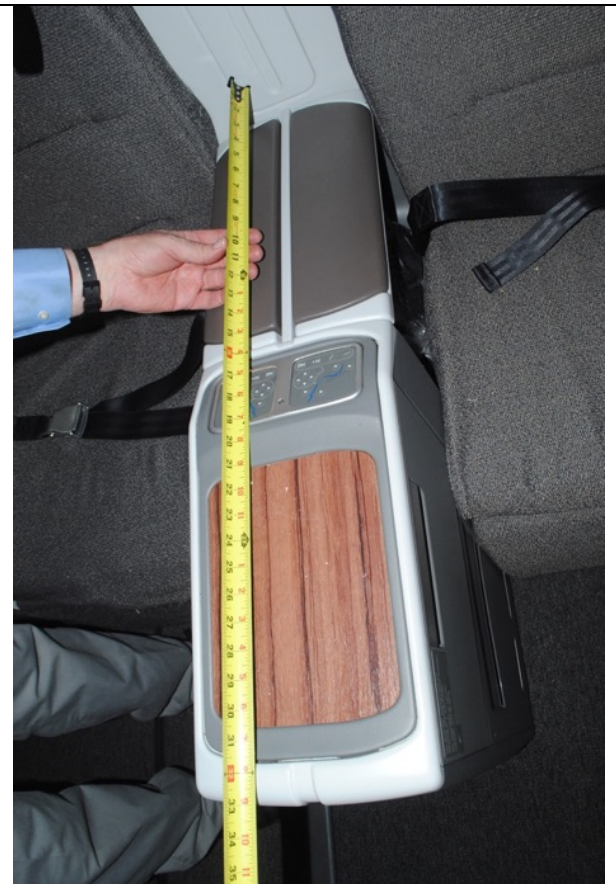
The business seat-A armrest abuts the fuselage wall as shown below. On the right side of the seat is a non-removable 33-inch long structure next to the seat from which a tray table can deploy with forward of that a flat area (normally) for seating drinks and snack (or tools and electronics). The photos here show the business seats in a full upright position where then the top of the seat cushion is 19-inches above the floor. The seat can fully recline flat, and when done so rides forward with a deployable mid-section that joins the top level of the footrests.

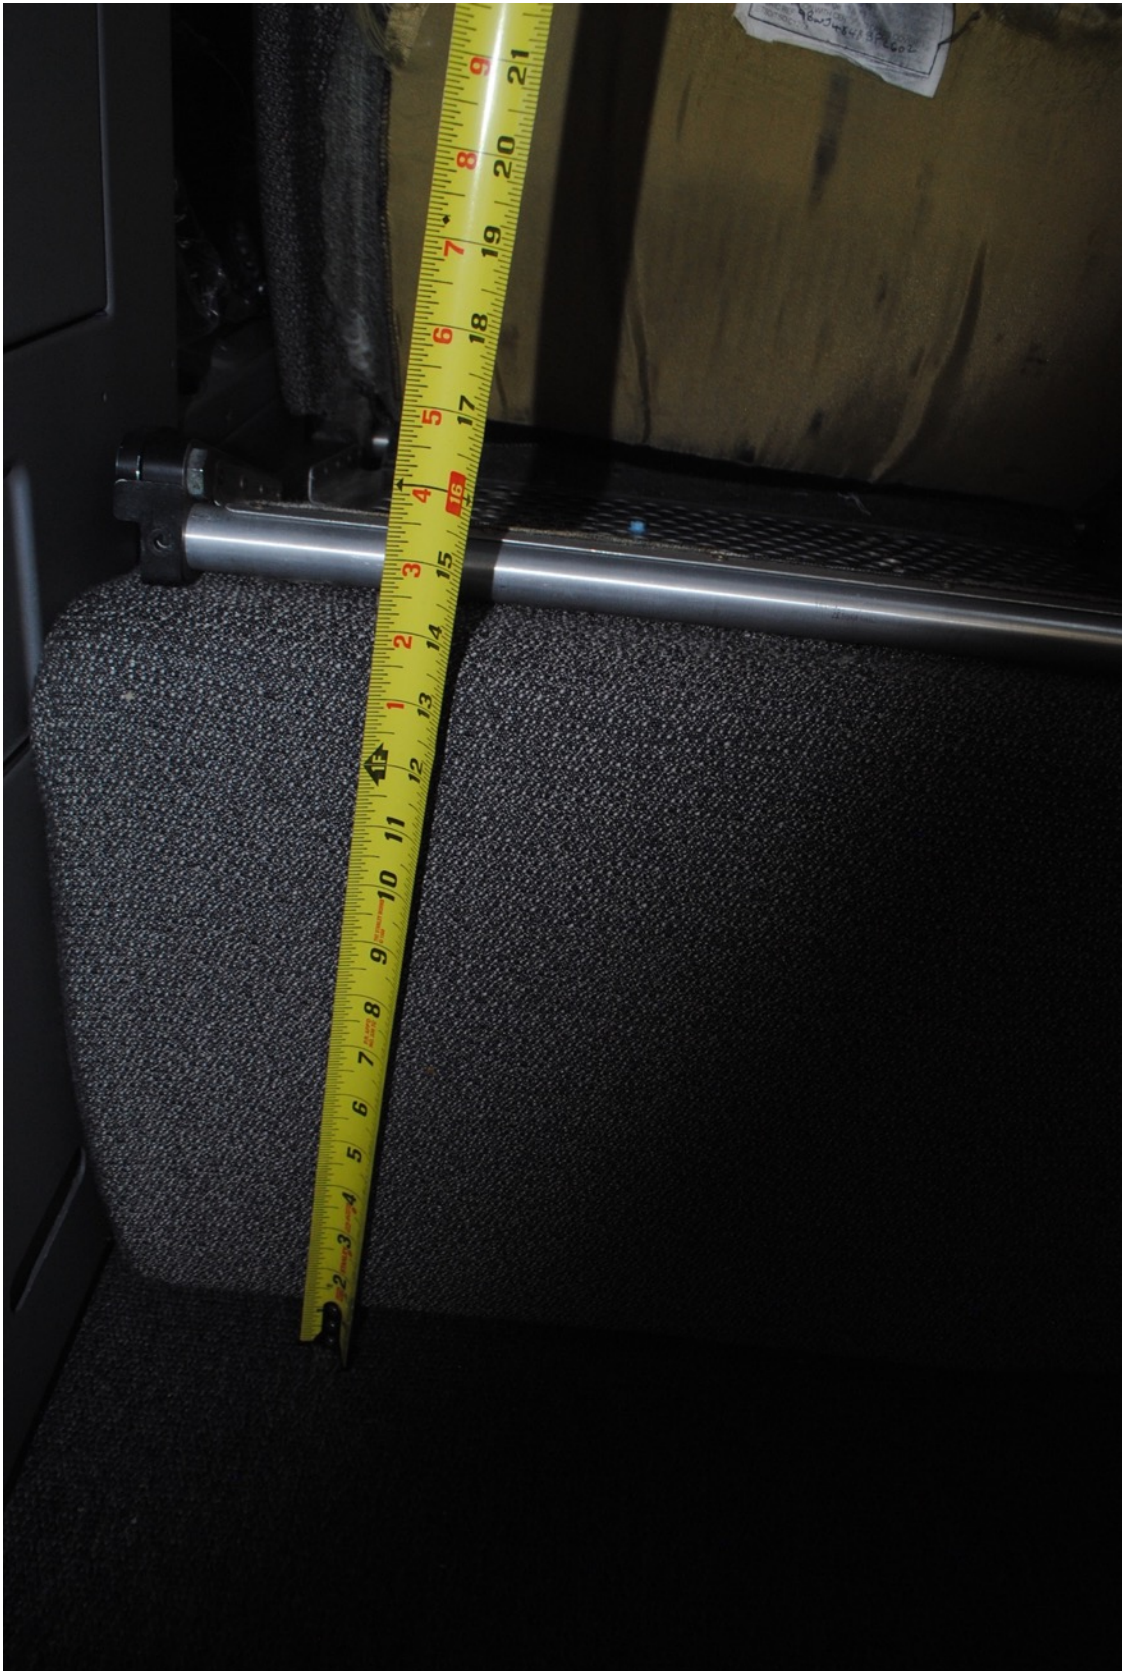
The business section seat cushions are also removable. If removed this exposes a flat frame surface behind a front positioning bar which is 15 inches above the cabin floor.

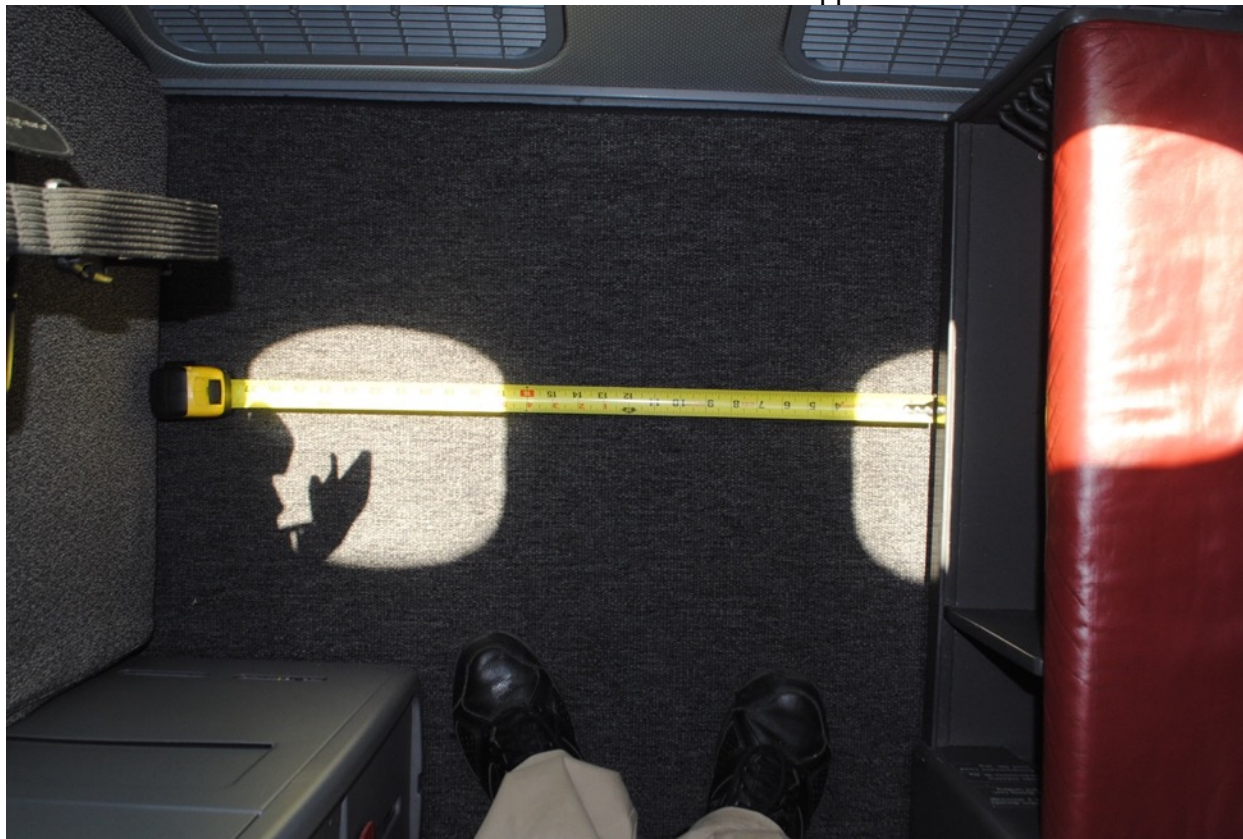
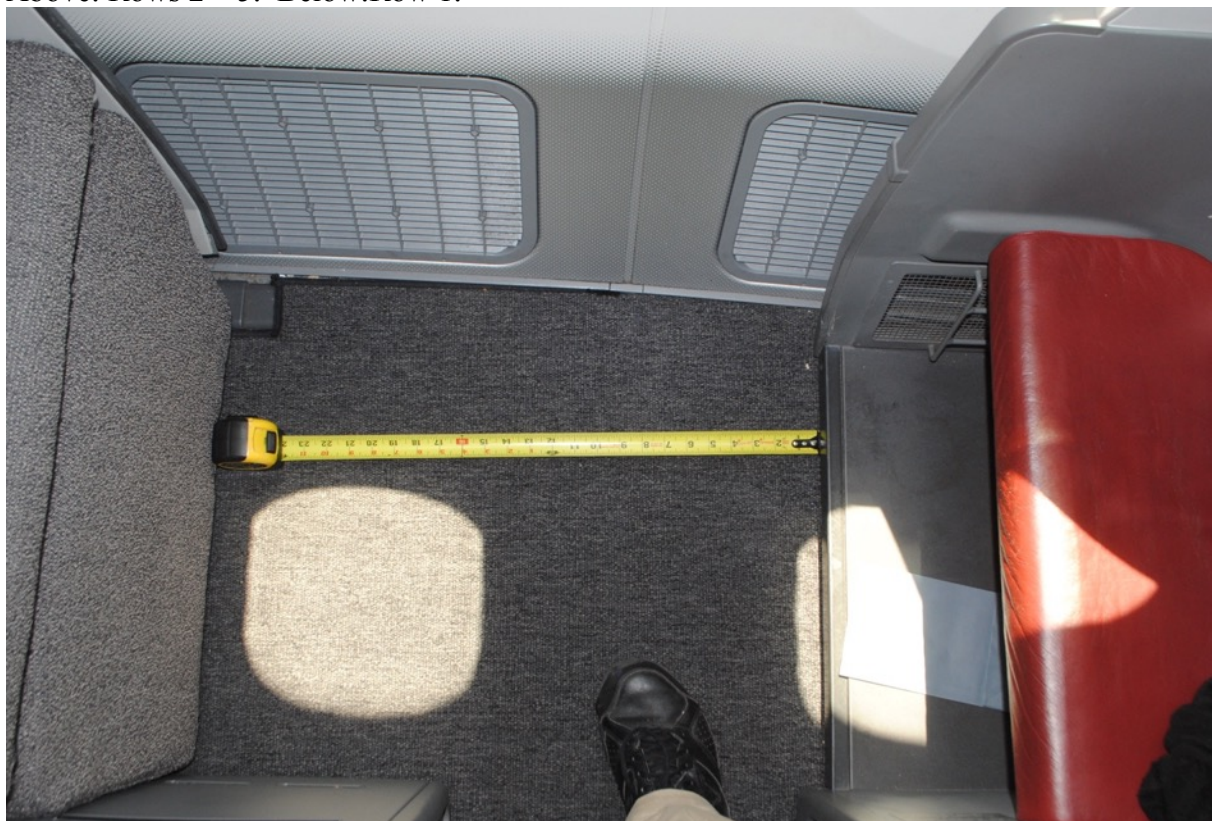
In rows 2-5, the cabin floor space (not including the footrest area) from the front of the vertical section of the fully upright business class seat below the front of the seat cushion to the front of the footrest is 30.5 inches. This is shorter in row 1 where it is appx 27 inches.

Above: Rows 2 – 5. Below: Row 1.

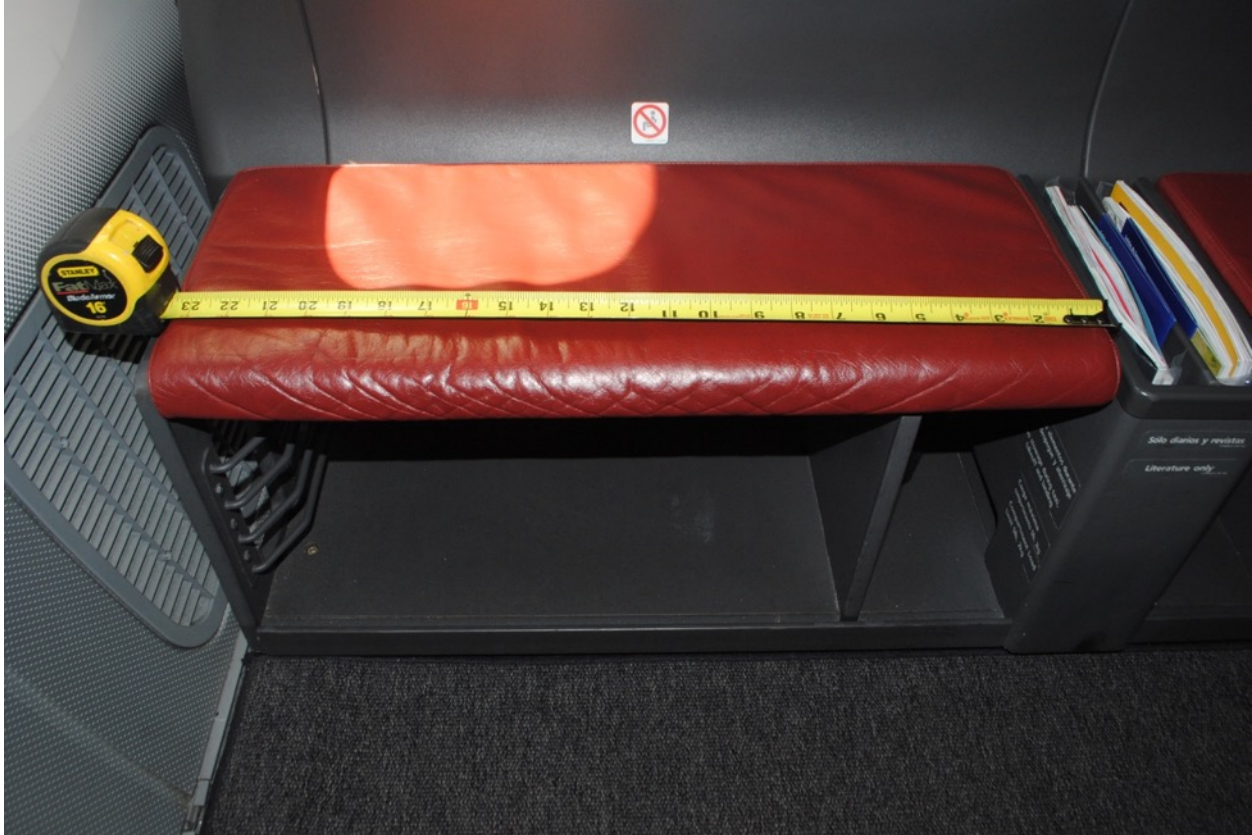
Here is what footstools look like in the front of rows 1-5, with the “storage areas” below.

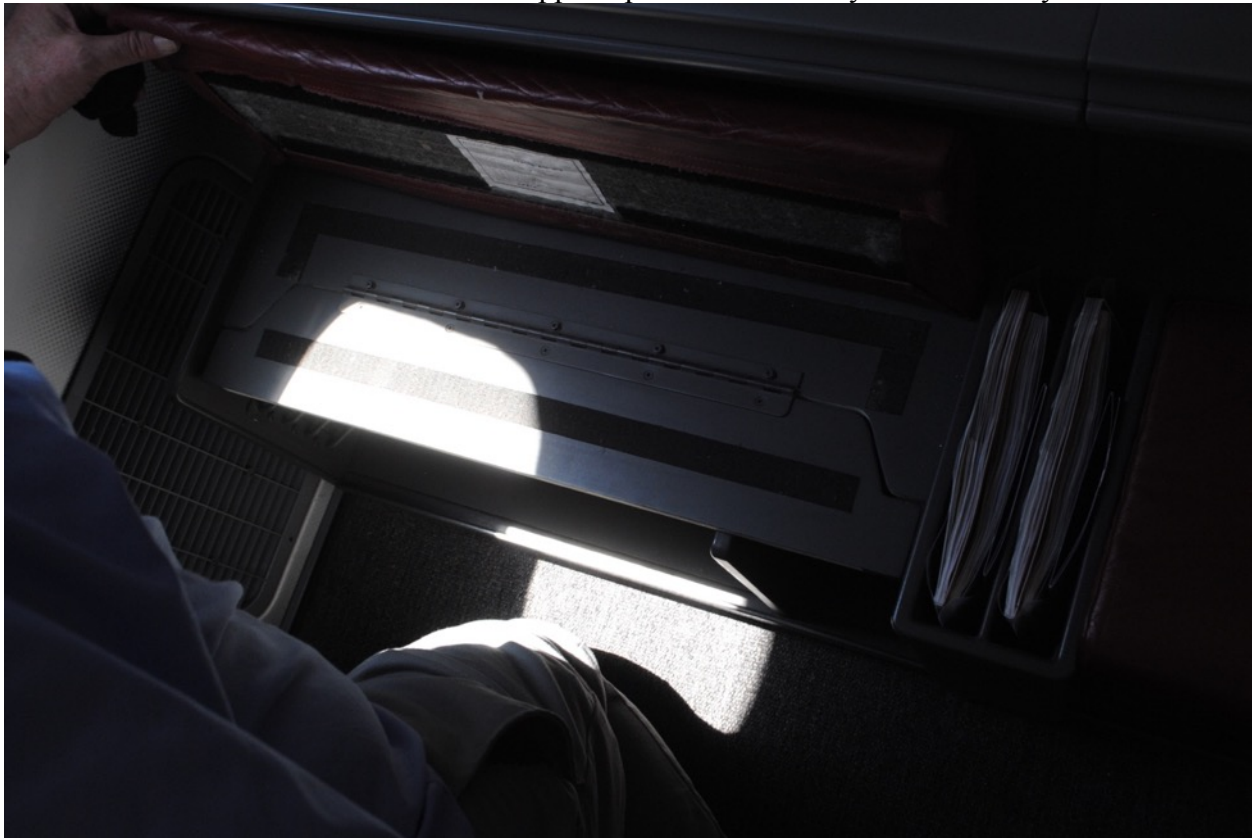
The magenta-red cover is velcroed on. It is easily removable, revealing a split, hinged, top surface of which more than half can be flipped up so is then mostly out of the way:

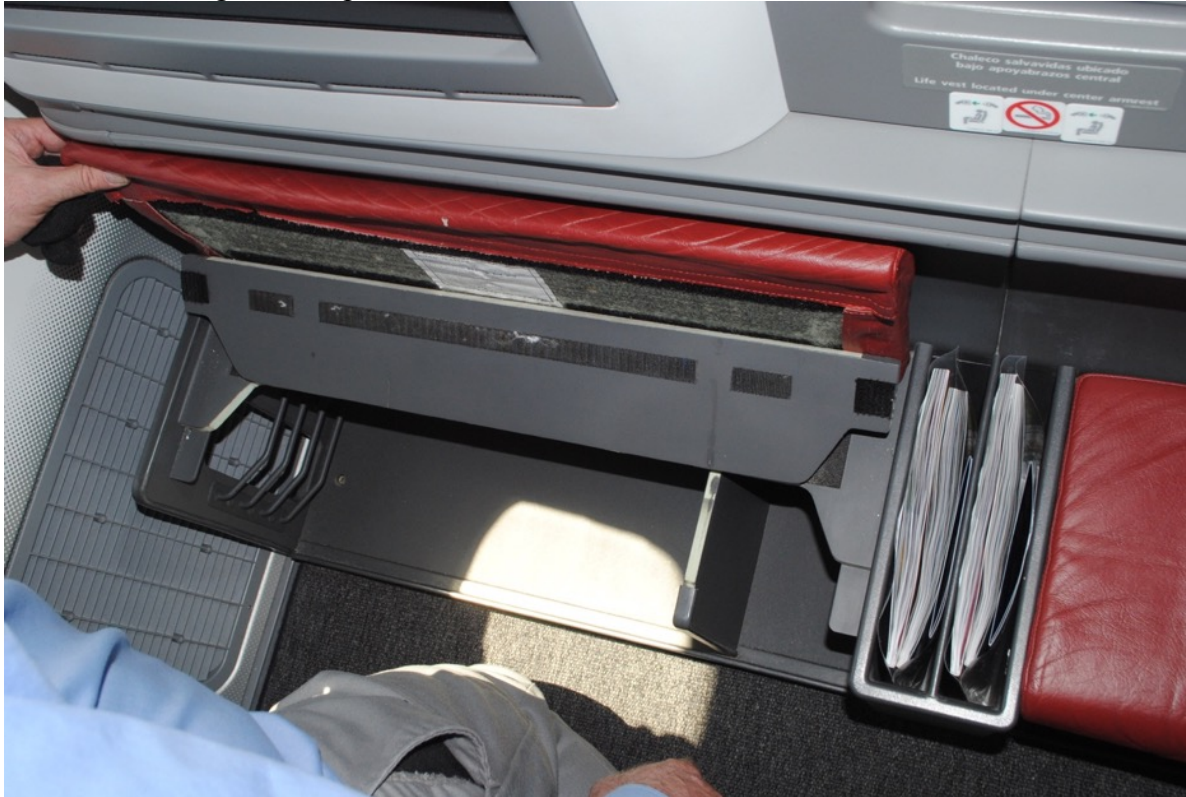
Here that is being folded up:

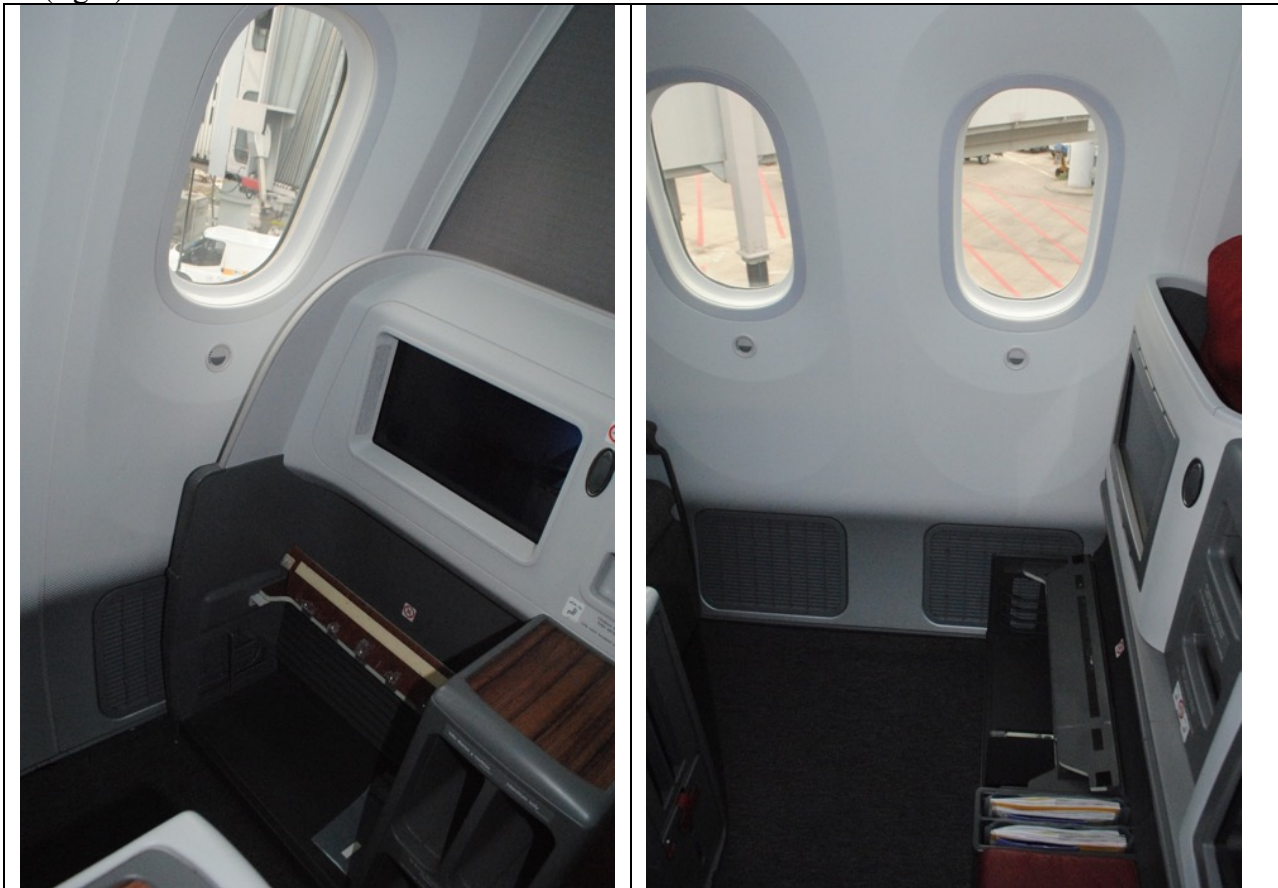
Here then is that space relative to the Y (middle window) and X windows in row 1 (left) and row 2 (right):

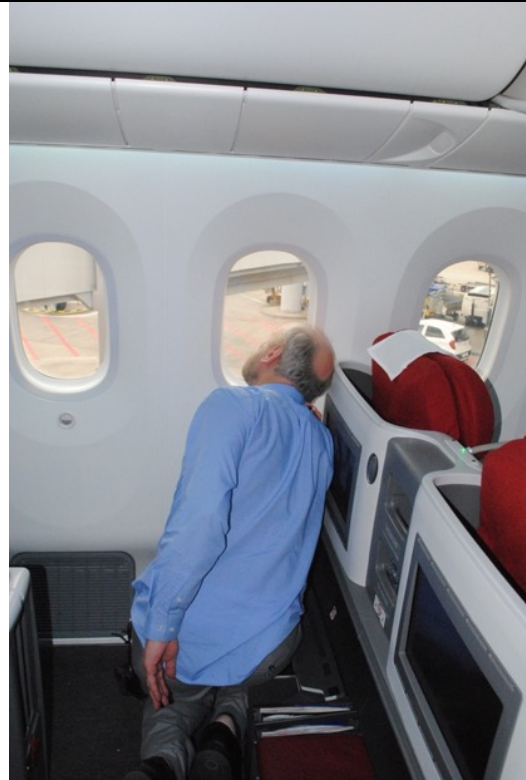
As a “Test” here is John Beattie, quite tall fellow, as he might hunker him/herself into that space for eclipse viewing with that photo taken looking forward from the seated position in seat 3A. (I wish I had caught John looking up, rather than to the left, but you can “get the picture”).

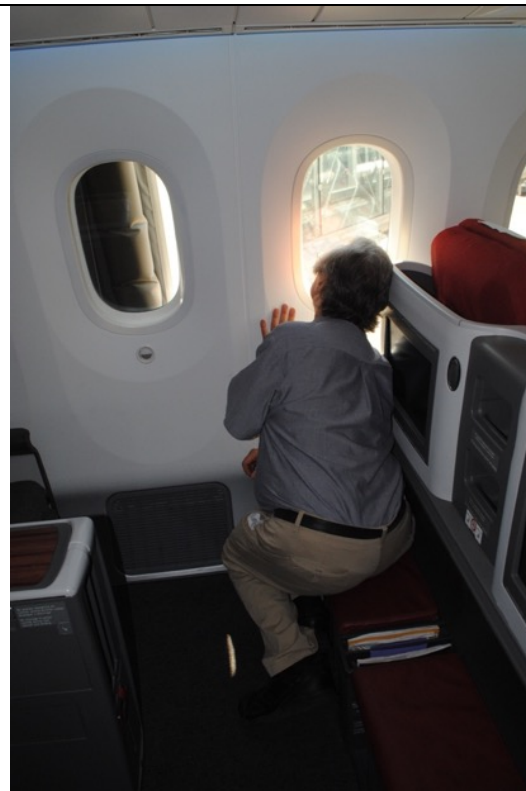
In this configuration, we found one person at the Y window and one person in the X window quite doable (though we did not get a photo of that). It is also possible, depending on the person size, to use the footrests in the flat, unfolded, top position and put a right derrière cheek on that:

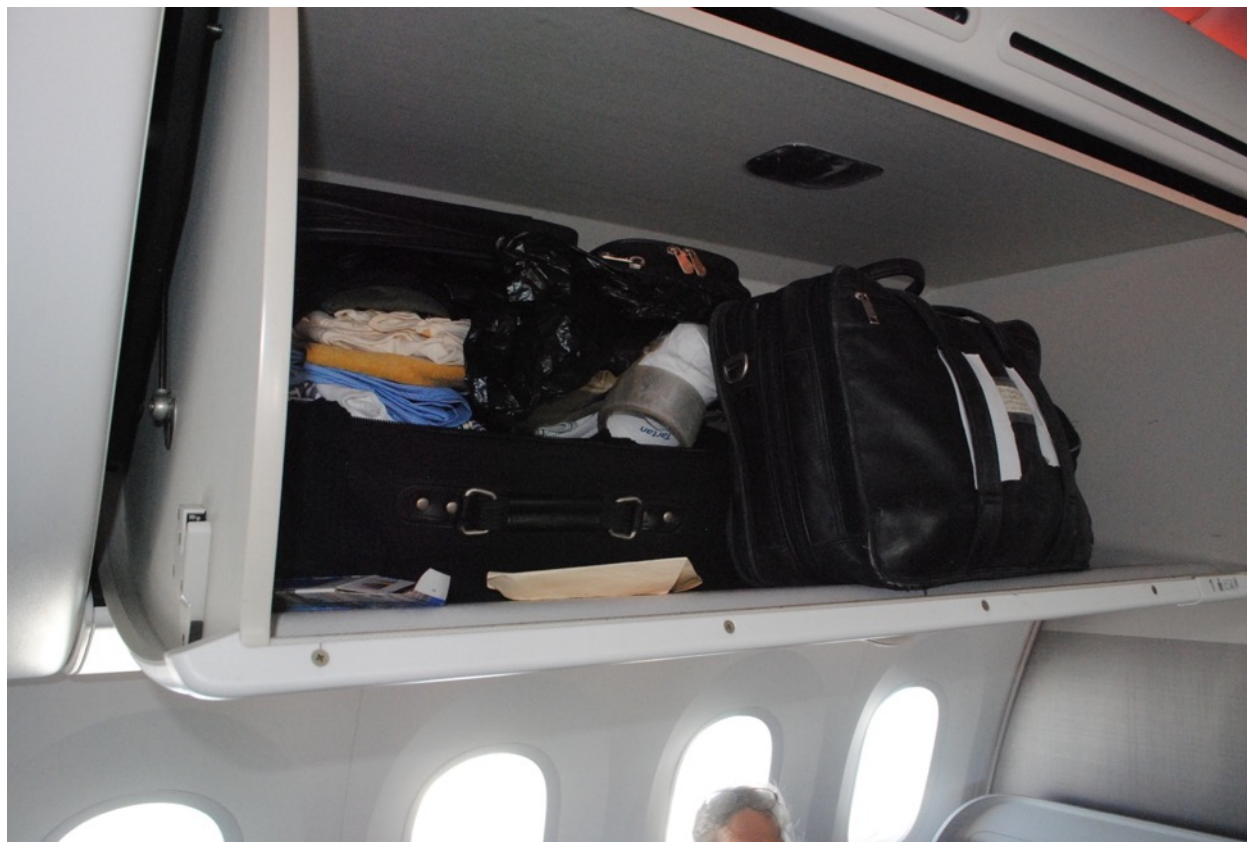
In both the Main and Business section cabins, there is plenty of storage space for eclipse-chaser carry-ons in the very large overhead bins. I did not get a measure of this, but you can judge from the photo below. The bottom of the bins when opened are very flat and nearly horizontal, and could be used to hold computers or other ancillary equipment as a working “shelf” to provide additional working area. Of course the storage bins above the middle section and anti-sun side seats can also be used for storage.
