LATAM B787-9 AIRCRAFT CABIN PHOTO-RECON & METROLOGY INSPECTION PREFLIGHT & POST-FLIGHT MADRID->FRANKFURT AUG 01, 2018

(updated: 05 Sep 2018)

Glenn Schneider and John Beattie (TSE 2019/EFLIGHT 2019-MAX)

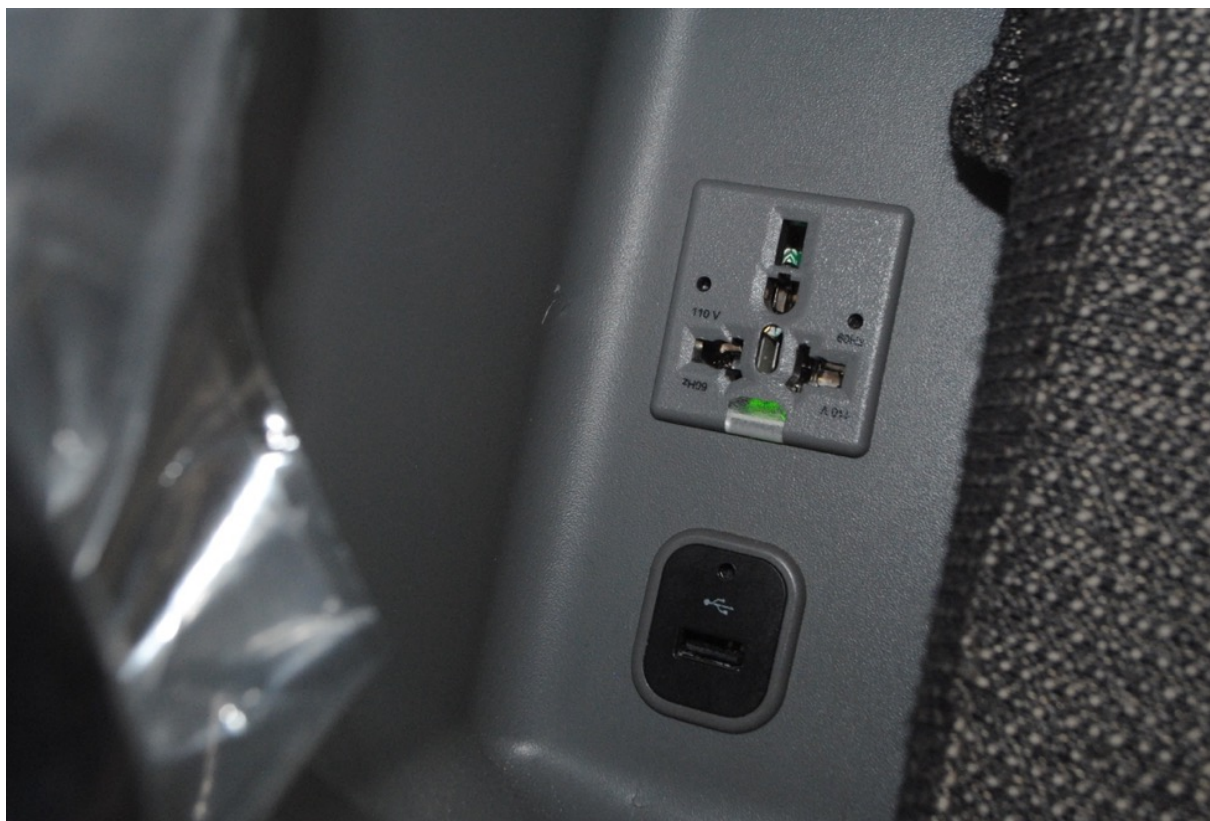
Both 110VAC/60Hz and USB power is provided in every passenger row – two sockets per row. If you need more than one power outlet, then either bring a “splitter” or extension cord to plug into another seat distribution point – but avoid running power cables that someone could trip over (i.e., tape down with duct tape or gaffers tape appropriately). The power sockets in the econ section are located on the seat backs of the row in front of your seat. In the business cabin, they are located next to your own seat back. The AC power sockets themselves accommodate U.S., European, and UK style power plugs (but note in all cases deliver only 110 VAC/60 Hz, **NOT** 220 VAC/50 Hz). The sockets are shown below, along with a photo of John Beattie using one to power a 75 Watt flood lamp*. Note: I have found that if you plug in a heavy, and off-center-balanced power supply charger (like an Apple MacBook Pro charger) with its short stubby power plug, it will likely fall out of the vertically mounted socket due to its own off-center weight. So if you will be using a modular power supply like that, bring an extension cord.

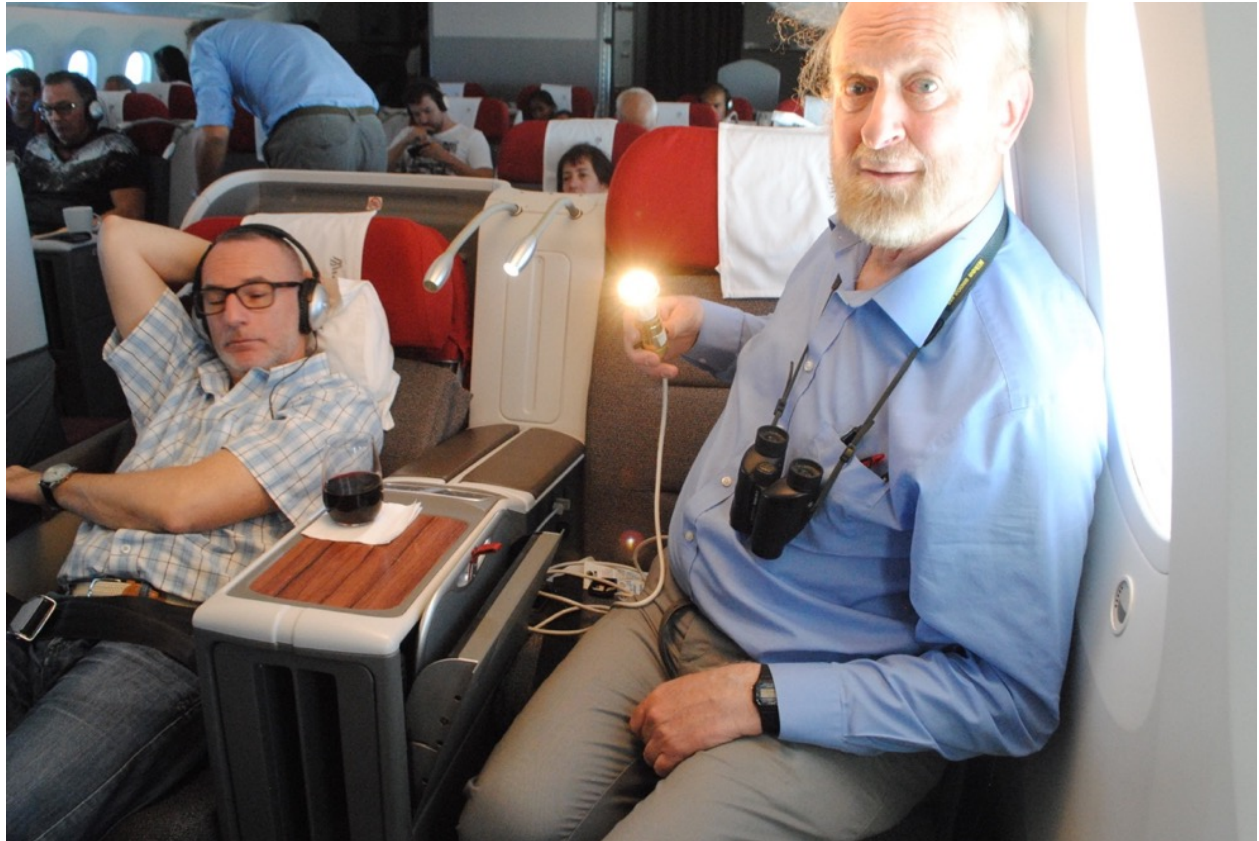
Note: Window frost formation within the redesigned B787-9 window cavity is unlikely. We none-the-less will have several 75-Watt flood lamps on board our EFLIGHT 2019-MAX -- “just in case”. Window frost dissipation with such lamps is accomplished with their **radiant** (not convective or conductive) heat. We first demonstrated the effectiveness of this approach on our ex-Tahiti EFLIGHT flight in 2010. Such lamps were available for use on our ex-Billund 2015 eclipse flight (but were not needed). We have further tested this on other non-eclipse flights since then. We have found this steady radiant heat injection works somewhat slowly, but indeed steadily creates a sizable clean, clear, and expanding hole in such frost, dissipating the frost within a period of about 10-15 minutes. (By contrast we have found that **convective** heat

sources such as hair dryers are not effective in combatting frost formation on the inner window surfaces). In any event, while we conservatively will carry these lamps onboard, we expect doing so will be purely academic. On this Madrid-to-Frankfurt B787-9 inspection flight we only found only one left-side window which, while we were on the ground only, had a small amount of condensation moisture (not frost) which fully disappeared on its own soon after takeoff. We anticipate in all likelihood a similar set of clear left-side windows ex-Easter Island for EFLIGHT 2019-MAX... but if frost should develop on any of the windows, we'll be well prepared to dispose of it.

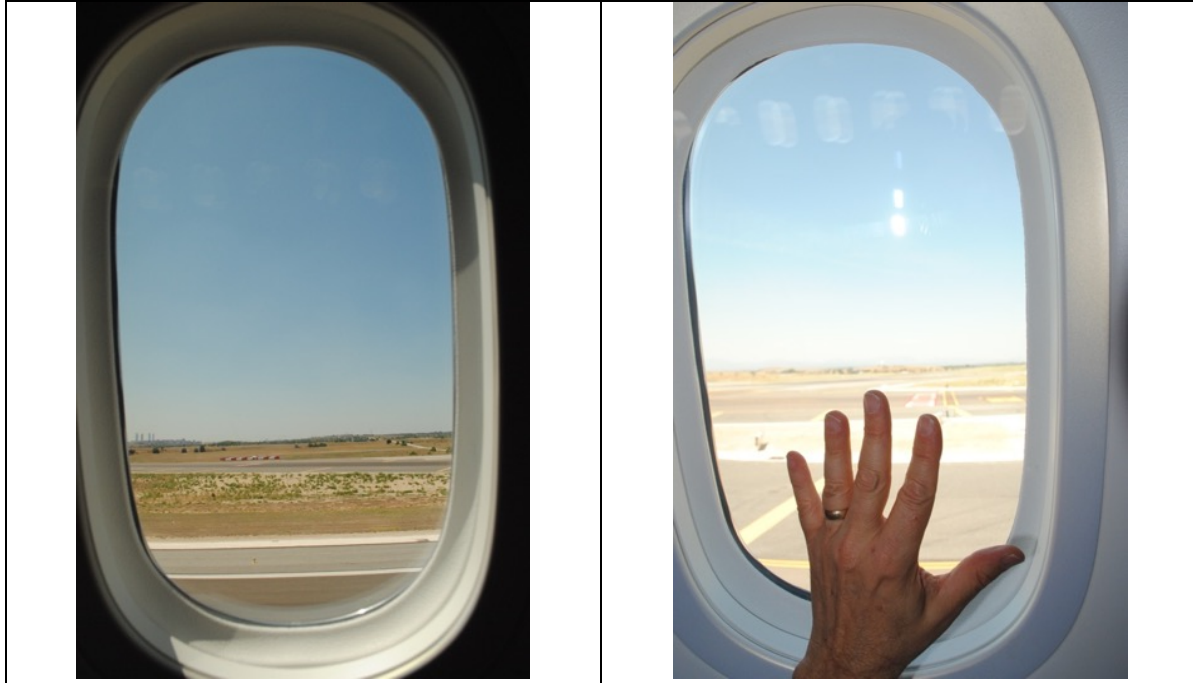
The windows really are HUGE (tall). 47cm x 27 cm. It is hard to really “get” this until looking out of one of them. It is hard to get a sense just looking at a photo of a window, so here is one, and then with my hand for comparison.

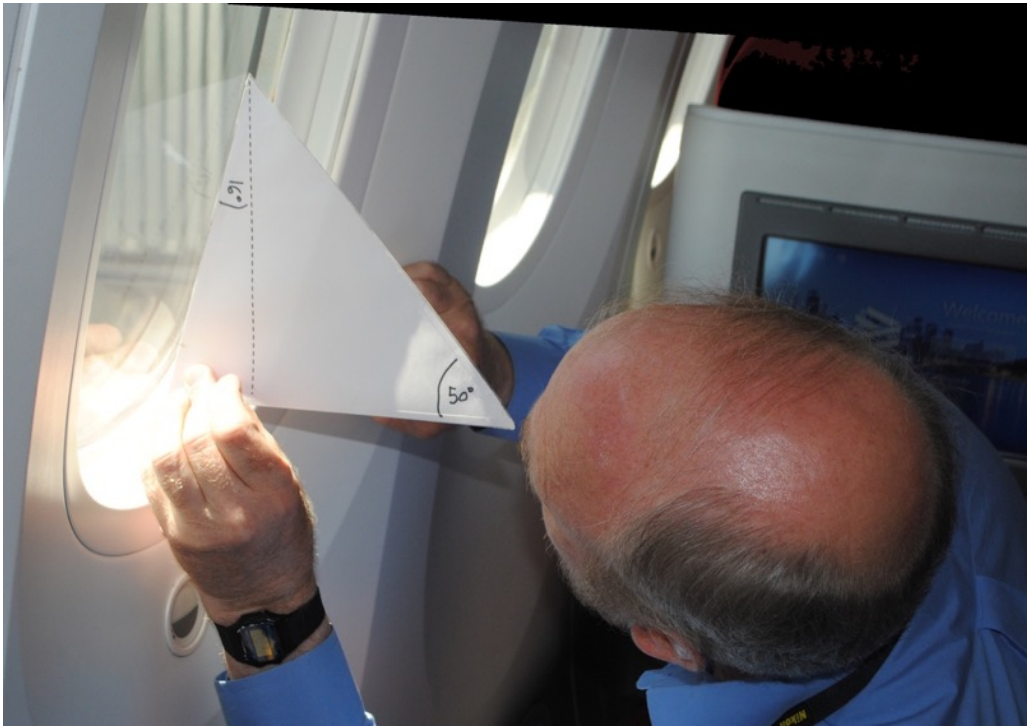
There is absolutely no problem looking “up” through these windows at our totality solar elevation angle of 50 deg. We tested this with the Sun nearly straight out the windows at 63 deg, and had plenty of unobscured space above even that – and confirmed the windows are tilted at the top toward the cabin interior by 16 deg.

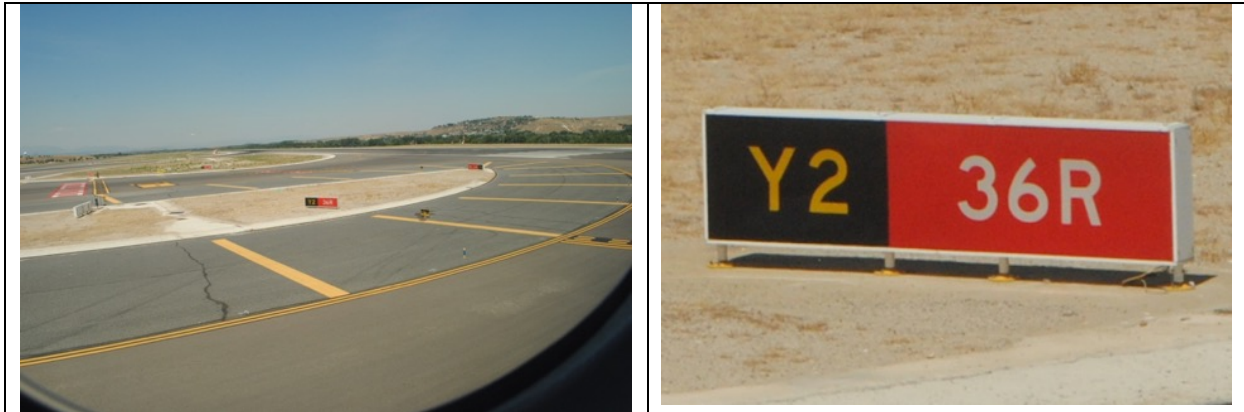
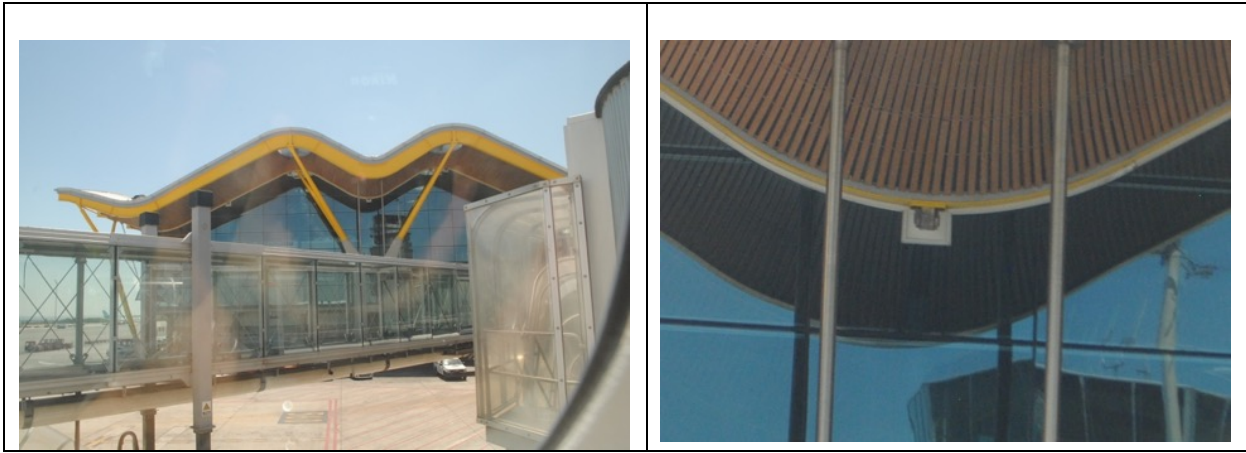
Visually the window quality seemed excellent, but I did not have an opportunity to photograph the Sun itself through the windows. I did however take some photos through the windows. I did not have a “long” lens but only a 24 – 55 mm EFL zoom used at the 55 mm EFL. The camera has only a 10 Mpix sensor, so is not very “high res” and in zoomed in display the image quality is limited by the pixilation of the sensor and not the quality of the windows.

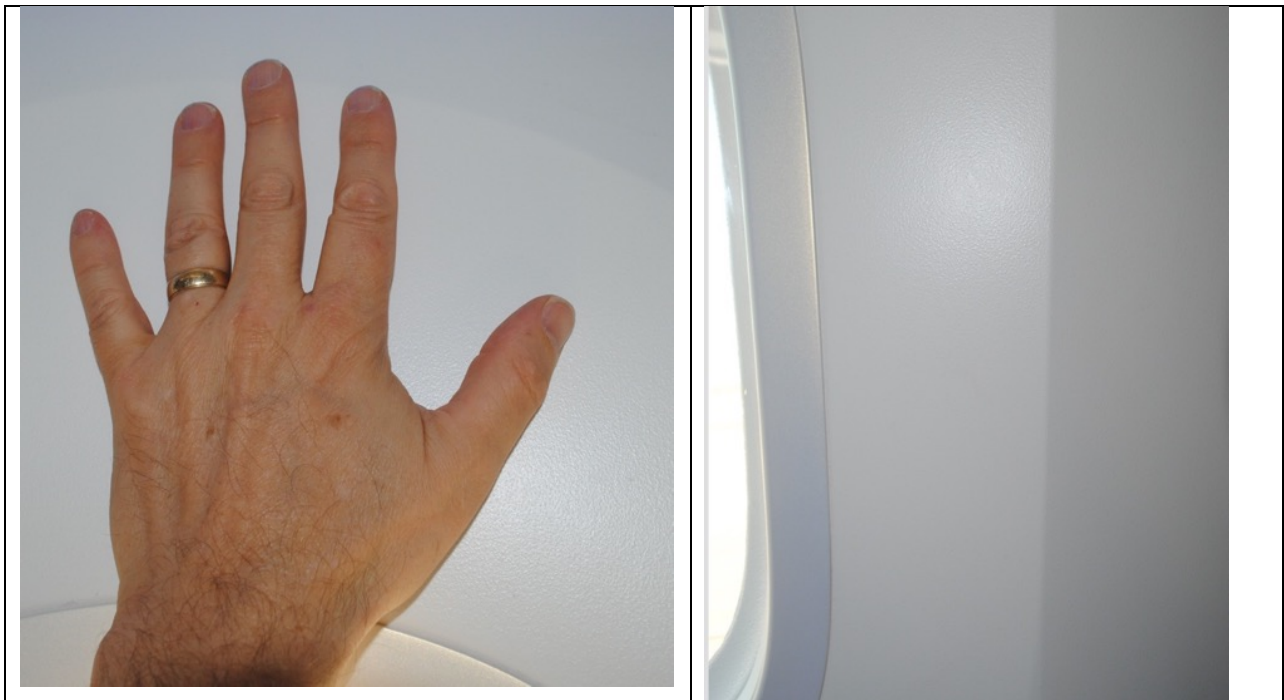
If you are considering the use of a vacuum suction cup to affixed to the aircraft window to hold a camera (up to a reasonable weight of course) I found the plastic window cover should mechanically work fine. I found the B787-9 transparent window covers, however, a bit thinner and slightly more flexible than on prior aircraft and I could feel very low amplitude high-frequency mechanical vibrations transmitted to their surfaces due to the engines in flight. This likely would be mostly damped by a rubber or silicon suction cup itself, but I would suggest if possible to use a vibration reduction or image stabilized lens.

Related: If you are considering placing such a camera-mount suction cup on the cabin wall beyond the window-frame bezel that is a more ridged surface. However, the wall itself is not smooth like the window pane itself, but is very lightly stippled (textured). See photos of the wall around the window frame (zoom in with a PDF viewer). The stippling is very shallow, but may be enough to prevent a good vacuum seal. For that I suggest the use of a vacuum grease, e.g.:
